Re: Trancor Mirador Subdivision; Construction Stormwater; SIC 1522; NPDES Compliance Evaluation Inspection; NPDES #NMU001978; September 13, 2018

#### **NPDES Compliance Inspection Report**

#### Mirador Subdivision Trancor Development Corporation NMU001978

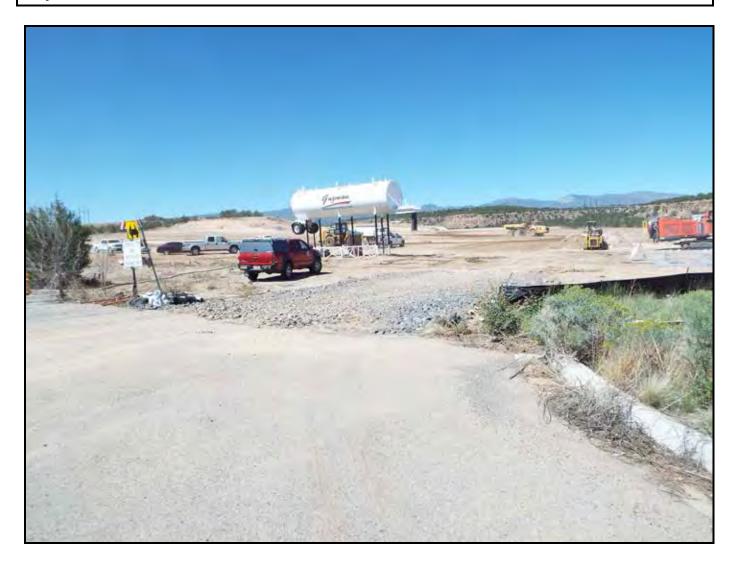
## Photo # 1

| Photographer: Daniel Valenta | Date: 9/13/2018 | Time: 1254 hours | | | | |
|---|---|---|--|--|--|--|
| Subject: Entrance to Mirador Subdivision a 50-acre subdivision. | | | | | | |

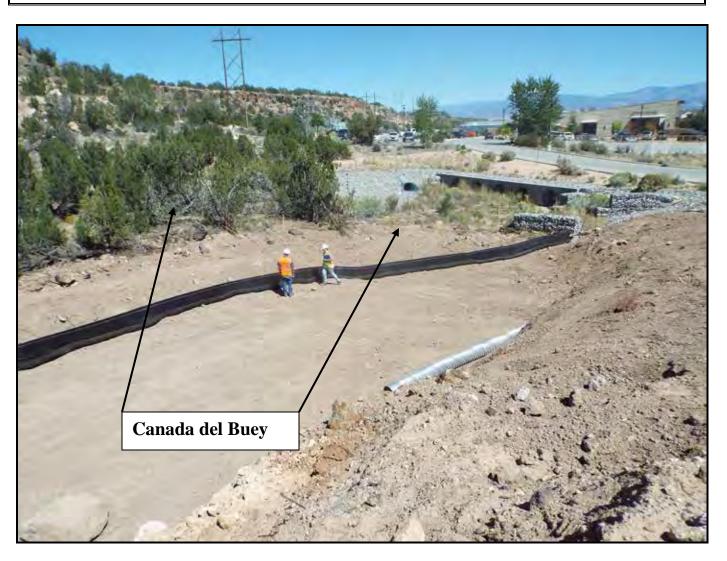
# Photo # 2

| Photographer: Daniel Valenta | Date: 9/13/2018 | Time: 1342 hours | | | | | |
|---|---|---|--|--|--|--|--|
| Subject: East side of subdivision which borders the Canada del Buey a waters of the US. | | | | | | | |

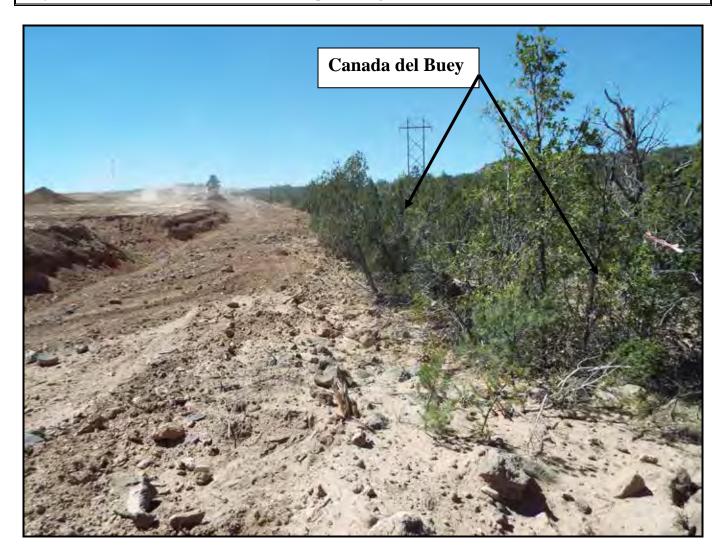
# Photo #3

- Almost the entire site has been regraded and prepared for development. It was estimated the disturbance begin around June 20, 2018.
- The site is located next to the Canada del Buey. The US Corps of Engineer has visited the site and determined the Canada del Buey to be a water of the US.
- Transcor Development Corporation is the property owner with day to day control and oversight has not applied for or received a Construction General Permit (CGP).

| Photographer: Daniel Valenta | Date: 9/13/2018 | Time: 1351 hours | | | | |
|---|---|---|--|--|--|--|
| Subject: Construction activities have moved dirt up to the edge of the Canada del Buev. | | | | | | |
